# Journal of Engineering Science and Technology Management

## Efforts to Reduce Cargo Residue After Tank Cleaning Last Cargo Palm Stearin to Next Cargo Palm Olein in MT Loading Tank. TIRTASARI

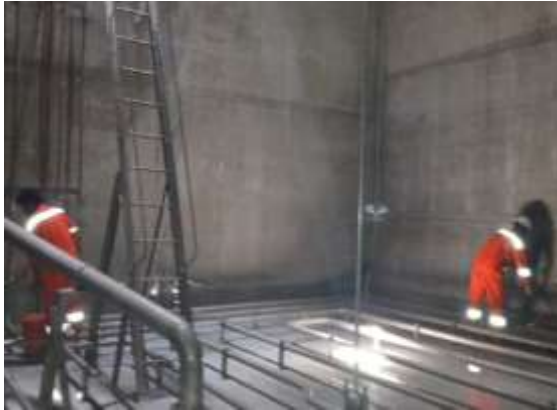
**Figure 3.** Cargo Residue on Loading Tanks

This section analyzes the technical mechanisms by which the identified operational deviations directly resulted in the failure of the tank cleaning process and the subsequent contamination of the cargo tanks (5S, 4P, and 3P).

Mechanism of Failure: Caustic Potash (Potassium Hydroxide) is a strong alkaline agent specifically required for Palm Stearin because it induces saponification—a chemical reaction that converts fats (triglycerides) into soap and glycerol, which are water-soluble and easily flushed. Multipol, used as a substitute due to stock unavailability, failed to trigger this saponification process effectively at the dosage used. Without the chemical breakdown of the fatty acids, the stearin residue remained hydrophobic (water-repelling) and adhered to the tank bulkheads despite the mechanical spraying, directly leading to the residue spots found during inspection.

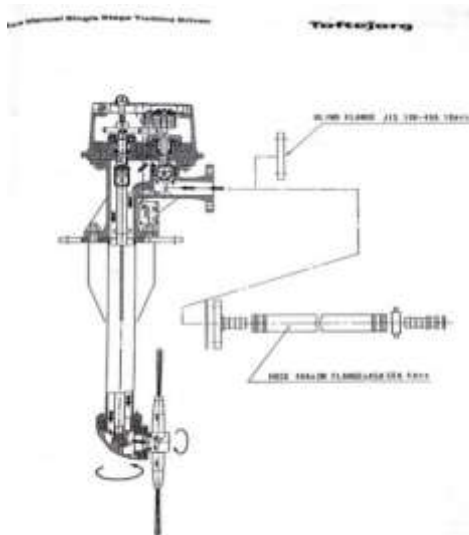
**Figure 4.** Butterworth tank cleaning machine

Mechanism of Failure: The "Butterworth" cleaning mechanism relies on the

combination of thermal energy (to melt the residue) and kinetic energy (impact of water). By rinsing at only 60-65°C for a shortened duration, the tank walls did not achieve the necessary thermal inertia to keep the stearin in a liquid phase. Consequently, the residue rapidly cooled and re-solidified on the stainless steel plating before it could be stripped by the stripping pump. The shortened duration meant the total heat energy transferred to the tank structure was insufficient to overcome the high melting point of the stearin layers.

The effectiveness of the cleaning media was further compromised by mechanical inconsistencies. The study found that pre-operational inspections of the Butterworth machines were neglected.

Mechanism of Failure: The Butterworth machine is designed to rotate on two axes to ensure 360-degree impact coverage. Observations indicated intermittent rotation failures. From an engineering perspective, when a machine stalls or fails to rotate, specific sectors of the tank (shadow sectors) receive zero impact energy. In these shadow zones, the residue is neither mechanically dislodged nor thermally treated, leaving

thick layers of solidified cargo that require manual "mopping" to remove.
