Map of Environmental Road Conditions in Lereng Village Kuok District Using GIS

Muhammad Agus¹, Beny Setiawan², Agus Alisa Putra³

^{1,2,3} Civil Engineering Study Program, Faculty of Engineering, Universitas Pahlawan Tuanku Tambusai

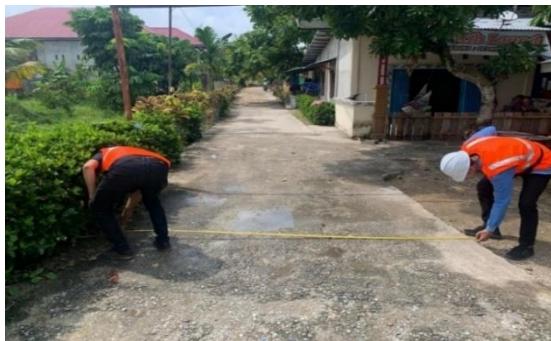
Figure 2. Environmental Road Measurement

Existing conditions show significant variations in damage across these road sections. Damage indicators found in the field include potholes, patching, cracking, and depressions. On Transad Road, for example, the total road area is 8,384 m², of which nearly 42% is damaged. The predominant types of damage on this section are random surface cracks, gaping potholes, and the detachment of road material due to weakened asphalt binding capacity. These physical findings indicate a decline in the quality of road services that can compromise the comfort and safety of road users.
