Root Cause Analysis of Alternator Mechanical Degradation and Cascading Electrical Voltage Instability in Shipboard Auxiliary Engines: A Case Study of MV. Hanglima

Bima Nurrahma¹, Antonius Edy Kristiyono², Agus Prawoto³, Shofa Dai Robbi⁴, Sri Mulyanto⁵

^{1,2,3,4,5} Teknologi Rekayasa Permesinan Kapal (TRPK), Politeknik Pelayaran (Poltekpel) Surabaya

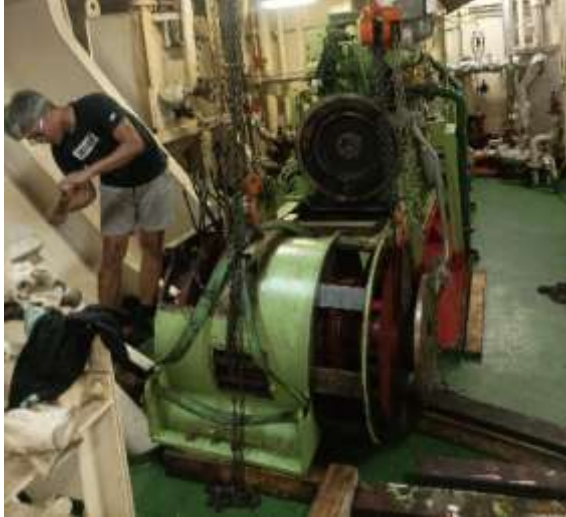
involved cracked alternator bearings, likely caused by engine overspeed or inadequate maintenance; this structural failure prevented the bearings from stabilizing the shaft, resulting in friction between the rotor and stator.

Figure 1. Overhaul Alternator Auxiliary Engine 2

This mechanical imbalance led to severe electrical consequences, specifically the abrasion of the copper winding insulation, which resulted in short circuits and voltage leakage that compromised the generator's output. These issues were exacerbated by methodological deficiencies, such as the absence of routine performance testing, and the utilization of non-standard or defective spare parts in an attempt to reduce costs, which collectively degraded the alternator's stability and overall efficiency.

The restoration process for Auxiliary Engine No. 2 necessitated a comprehensive overhaul, beginning with the dismantling of the alternator from the generator shaft to access the internal components. Diagnostic procedures included a Megger Test to evaluate insulation integrity; upon detecting leakage, the existing insulation was stripped using a chemical varnish remover, followed by the application of a new insulating varnish spray to ensure complete coverage and sealing against future leaks.

Following the re-insulation and a subsequent confirmatory Megger Test, the damaged bearings were replaced with original spare parts as specified in the manual book to ensure precise fitment and
