Optimizing The Implementation of Tank Cooling down to Prepare for The LNG Loading Process on LNG Carrier Pan Africa Ships

Muhammad Ahyar Dzaky^{1,a,*}, Sutoyo^{2,b}, Elly Kusumawati^{3,c}, Anugrah Nur Prasetyo^{4,d}

^{1,2,3,4} Teknologi Rekayasa Operasi Kapal (TROK), Politeknik Pelayaran (Poltekpel) Surabaya

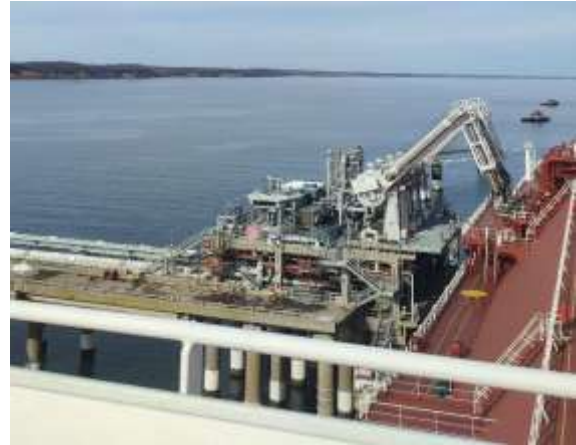
and attaching loading arms (Nos. 2, 3, 4, and vapor arm), followed by nitrogen purging to reduce oxygen content below 1% and leak testing at 5 bar pressure (Sugiyono, 2018). Once the "Initial Gauging" via the Custody Transfer Measuring System (CTMS) and ESD Cold Test were completed, LNG was introduced through the spray rails to gradually cool the tanks, with vapors returned to shore via HD Compressors to manage internal pressure.

Figure 1. Loading arm and manifold installation activities

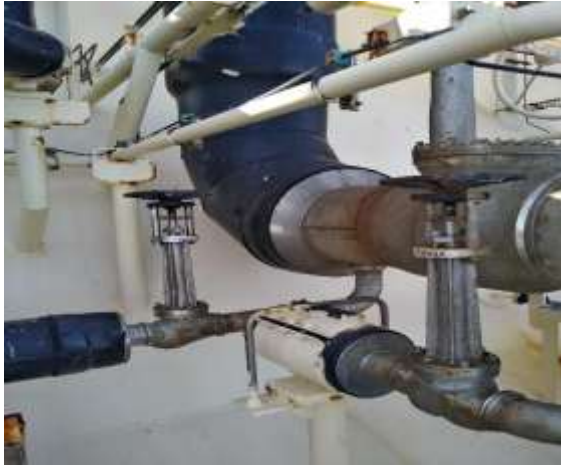
However, the cooling operation encountered a significant deviation on September 25, 2024. While the initial hour proceeded normally with a temperature drop from 40°C to 30°C, the cooling rate subsequently decelerated drastically, dropping only 10°C in the following hour. An Able Seaman on safety rounds discovered a leak in the cooldown valve at loading arm manifold No. 2. The Third Officer, alerted by the seaman and an alarm on the Integrated Automatic System (IAS) indicating a flow rate drop, immediately suspended operations (McLennan, 2015). The Cargo Engineer identified the root cause as a valve that failed to seal tightly due to a corroded handle. Consequently, operations resumed with loading line No. 2 isolated to prevent further leakage, though this incident highlighted a critical failure in pre-operational equipment verification.

Figure 2. Loading arm and manifold installation activities

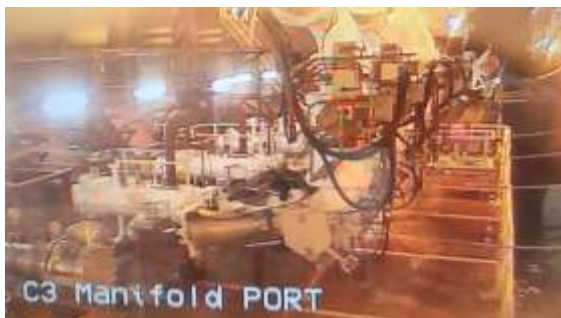
Figure 3. Leak in the cooldown valve

The Cargo Engineer provided a technical analysis of the failures, attributing the valve leakage to corrosion on the handle that prevented a complete seal—a clear indication of inadequate maintenance on infrequently utilized equipment. Furthermore, he highlighted a critical coordination failure regarding the nitrogen system; the nitrogen generator was not activated in time, resulting in the Inter-Barrier Space (IBS) pressure failing to reach the required minimum of 0.2–0.4 kPa. This oversight, caused by miscommunication between the watch officer and the engineering team, compromised the temperature stability of the insulation space and underscored the necessity for stricter adherence to Standard Operating Procedures (SOPs) regarding equipment readiness (Yeo, 2009; Tuan, 2015).

Operational efficiency relies heavily on adherence to the standard cycle time. Observations revealed a drastic drop in the cooling rate from 30°C/hour in the first hour to only 10°C/hour subsequently. From a production management perspective, this 50% efficiency loss is not merely a technical issue but a production loss. This deviation extended the operation duration, increased Heel (retained cargo) consumption, and added to "waiting time" waste (Downtime) at the terminal. The root cause was identified as a failure in Preventive Maintenance (PM): corrosion on the handle of the No. 2 loading line valve prevented a proper seal—a condition that should have been detected via function tests prior to port arrival.

1. Strengthen Preventive Maintenance: Mandate pressure/function testing for all cargo valves and auxiliary systems (Nitrogen) 24 hours prior to arrival, shifting from visual inspection to operational testing.
2. Integrated Communication Protocols: Implement a "Joint Readiness Check" between Deck and Engine departments to ensure utilities are stable *before* the critical path of the operation begins.
3. Risk-Based Competency Enhancement: Conduct simulation drills for cooling system failures to enhance crew situational awareness regarding pressure and temperature anomalies.
