Journal of Engineering Science and Technology Management

Optimization of Fire Hydrant Maintenance to Minimize Fire Incidents on Board MV. HABCO CARINA

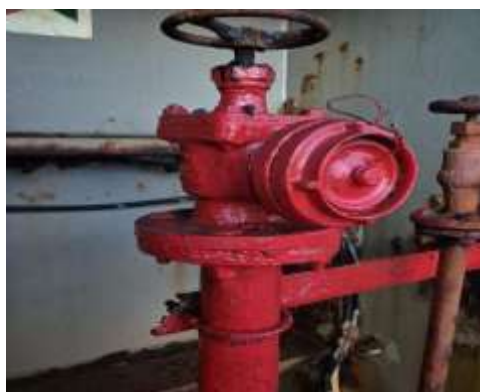
Field observations conducted on the MV Habco Carina revealed critical physical degradation across the fire hydrant system. As shown in Figure 1 and Figure 2, specific mechanical deficiencies included leaking hose couplings, loss of elasticity in rubber gaskets, and heavily corroded valve handwheels that hindered manual operation. These physical conditions constitute a direct violation of SOLAS Chapter II-2, Regulation 14.2.1.2, which mandates that fire-fighting systems must be kept in good working order and readily available for immediate use.

Figure 1. Fire Hydrant has experienced a decline in quality

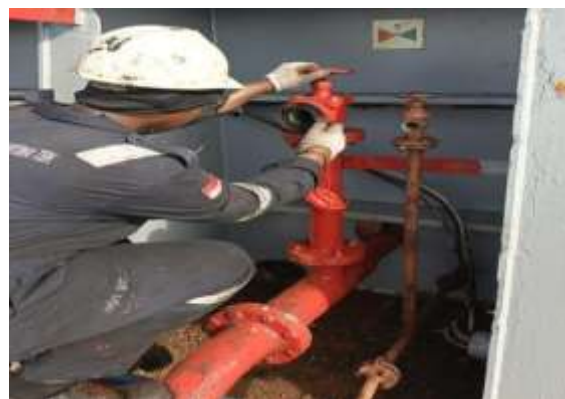
The impact of these maintenance failures was empirically demonstrated during the fire drill on April 10, 2024. The system failed to generate sufficient water pressure to reach the simulated fire targets on the main deck. Furthermore, the nozzle mechanisms were found to be obstructed by sediment and lacked necessary lubrication. This confirms the findings of Chasenda et al. (2024), who noted

that minor component neglect—such as a lack of greasing—directly correlates to total system failure during emergencies. The observed pressure loss indicates that the vessel is effectively operating on a "breakdown maintenance" basis rather than the required preventive regime.

Figure 2. Maintenance Fire Hydrant

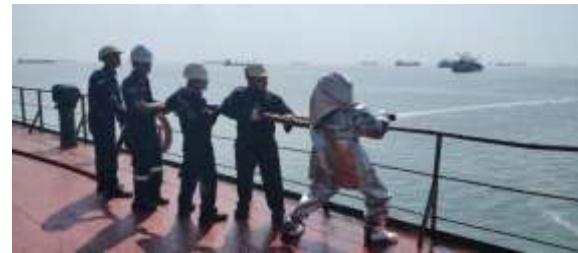
A comparative review of the Planned Maintenance System (PMS) Monthly Reports (Figure 3) and the actual visual evidence (Figure 4) reveals a significant administrative gap.

Actual Status: Physical verification

showed rusted valve spindles, seized couplings, and dry-rotted hoses.

Figure 4. Trying Fire Hydrant

This discrepancy indicates that the PMS is being treated as a clerical formality ("tick-box exercise") rather than a technical assurance tool. This practice violates the ISM Code (International Safety Management), which requires that non-conformities and defects be reported and corrected. The administrative compliance masks the latent failures of the system, creating a false sense of security (Widiatmaka, 2018).

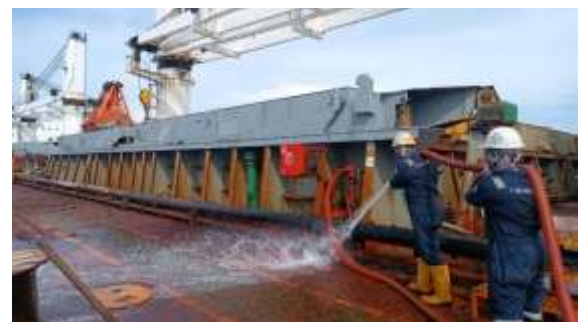
Figure 5. Cleaning Deck

Technical observations derived from the data reduction phase indicate that physical degradation is a primary consequence of these procedural lapses. Specific findings include leaking hose couplings, clogged nozzles, and stiff valve handwheels caused by insufficient lubrication, all of which contribute to water pressure levels that fail to meet operational standards. These mechanical deficiencies are exacerbated by administrative weaknesses, particularly incomplete logbook documentation that fails to record repair follow-ups. The analysis suggests that the root cause of these issues is not inherent equipment failure, but rather a lack of discipline in executing weekly physical inspections and insufficient oversight by the Third Officer regarding the vessel's safety assets.

To resolve these issues, the optimization strategy must move beyond simple technical repairs. It requires a managerial overhaul:
