Slab Cutter Machine Maintenance to Improve the Efficiency of Rubber Products at PT Bridgestone

Agustinus Foncianus Sitinjak^{1*}, Azarya Nimrod Juwono Siahaan²
HKBP Nomensen University, Pematangsiantar

DOI: 10.31004/jestm.v6i1.396

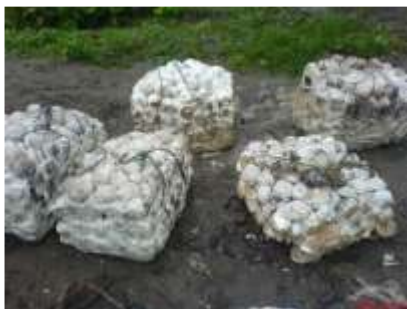
Figure 2. (Illustration) BSRE Lump

The above data indicates that structurally, the Slab Cutter machine at BSRE is in excellent condition, but requires special attention to the blade area and transmission system to maintain efficiency. Daily

observations noted that the buildup of rubber residue on the blade can increase cutting resistance, which, if not cleaned regularly, will result in uneven rubber cut edges and uneven particle sizes.

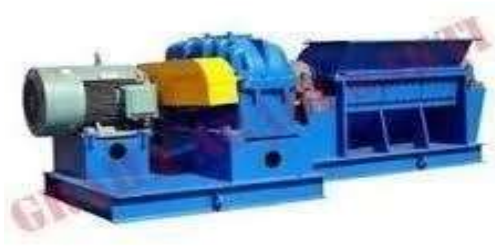
Figure 3. Slab Cutter Technique

The Slab Cutter machine operates on the principle of high rotor rotation, which drives a vertical cutting blade to strike a rubber slab that enters via gravity or a conveyor. The cutting force (F_c) generated by the blade depends heavily on the motor torque and the sharpness of the blade angle. Based on cutting machine design theory, the cutting force must exceed the maximum shear stress of the rubber at operating temperature.

| Machine Name | : Slab Cutter |
| Machine Function | : Raw Material Cutter |
| Motor | : 75 HP, 1,450 Rpm |
| Speed | : 58 rpm |
| Capacity | : 6,500 tons/dr |

Field observations show that when raw rubber slabs have a high-water content, the rubber tends to be stickier and increases friction between the blade and the material. This requires a cooling system (water spray) to operate continuously to reduce heat caused by friction and prevent the rubber from melting again and sticking to the blade surface. The use of 440C Stainless Steel blade material has proven effective in maintaining sharpness longer than ordinary carbon steel, while also preventing rust contamination in crumb rubber products.
