Journal of Engineering Science and Technology Management

Identification and Solutions for Cargo Loss on Self-Propelled Oil Barge (SPOB) Seroja V

ABSTRACT

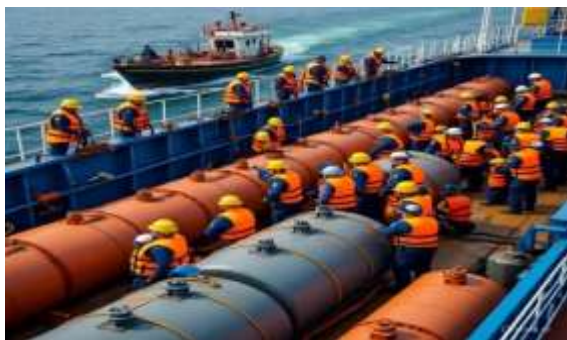
Figure 1. Theft and Pilferage

Theft and Pilferage: While less common in highly regulated terminals, the unauthorized removal of cargo—often disguised as sludge disposal or through bypass lines—remains a physical security risk in certain regions. SPOBs operating in remote riverine areas must be particularly vigilant against this form of loss.

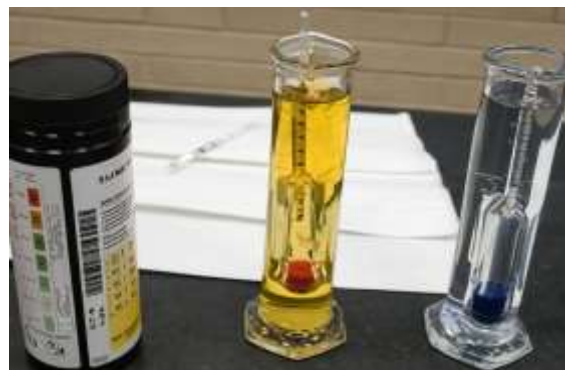
Figure 2. Calculation Discrepancies

Calculation Discrepancies: Errors in applying Volume Correction Factors (VCF) derived from ASTM tables (e.g., Table 54 for product conversion to standard temperature). Incorrect density inputs or failure to calibrate shore versus ship tank tables can lead to substantial variance. For FAME, the density-temperature relationship is critical; using a standard mineral diesel table instead of a specific biofuel table can introduce error.

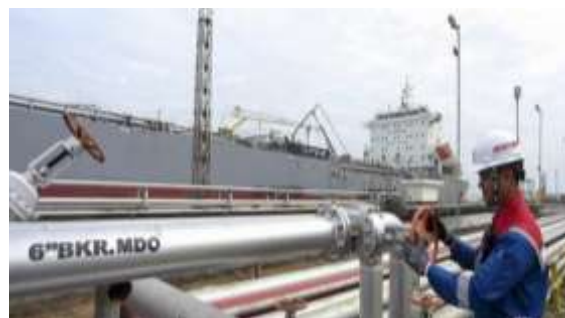
Figure 3. Instrument Calibration

Instrument Calibration: The use of uncalibrated or defective sounding tapes, thermometers, or flow meters can systematically skew volume readings. A stretched tape or a thermometer reading 0.5°C off can result in a calculated difference of thousands of liters over a full cargo load.

Equipment Calibration: The research implies that sounding tapes and thermometers are not always calibrated. A stretched tape reads a higher ullage (lower liquid level), artificially creating a loss record.

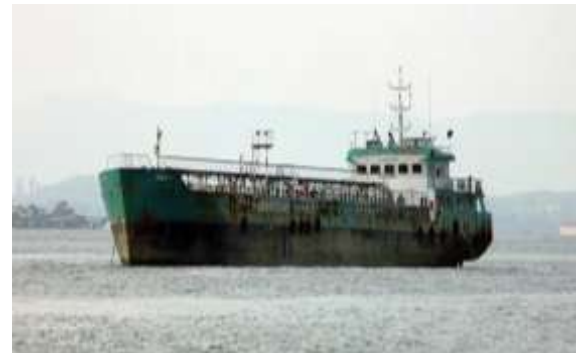
Figure 4. SPOB Seroja V

The SPOB Seroja V is a dedicated FAME carrier owned by PT. USDA Seroja Jaya. Its design particulars are critical to understanding its loss profile. With a length overall (LOA) of 87.26 meters, a breadth of 15.60 meters, and a depth of 5.60 meters, the vessel operates with a relatively shallow draft, suitable for riverine terminals like Plaju. The vessel utilizes a cargo system comprising 10 main cargo tanks (1-5

Port/Starboard) with a total capacity of approximately 4,000 Kiloliters.

Notably, the vessel lacks an automated cargo monitoring system (such as radar gauging or a centralized computer in a CCR); all gauging is manual, performed via sounding pipes on the main deck. The crew complement consists of 15 personnel. The deck department, responsible for cargo operations, includes the Master, Chief Officer, Second Officer, Boatswain, and Able Seamen (AB). The absence of a Third Officer or dedicated Pumpman places the burden of cargo line setting and pump operation heavily on the Chief Officer and Boatswain, increasing the workload and potential for fatigue-induced errors.
