Analysis of Performance Degradation of the Refrigeration System on MT Nolowati III

Sahrul Romadon¹, Moejiono², Mochammad Zainuddin³, Agus Prawoto⁴, Prima Yudha Yudianto⁵

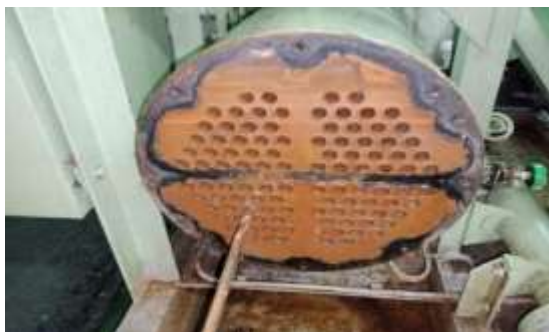
To substantiate the findings from earlier surveys and interviews, a documentation study was conducted to provide physical evidence based on primary data collected during the author's sea service on the MT Nolowati III. The analysis revealed that the condenser grilles were heavily obstructed by accumulated clumps of dirt, a condition that underscores the critical need for rigorous and routine inspections of the machinery to prevent recurrence. The specific results of this documentation review are detailed as follows:

Figure 1. Clogged Condenser

Through triangulation of the physical inspections and interview data, the RCA identified that the primary driver of system inefficiency was not a refrigerant leak, but rather a severely clogged condenser. The accumulation of clumps of dirt on the condenser grilles acted as an insulator, drastically reducing heat transfer. According to thermodynamic principles, this obstruction forces the condensing pressure and temperature to rise, which overloads the compressor and decreases the net refrigeration effect.

Immediate corrective maintenance involved a comprehensive overhaul of the cooling unit. The technical team executed mechanical cleaning of the condenser to remove the physical obstructions, restoring unobstructed airflow. Simultaneously, the thermostat was recalibrated, and the malfunctioning condenser fans were repaired. These interventions

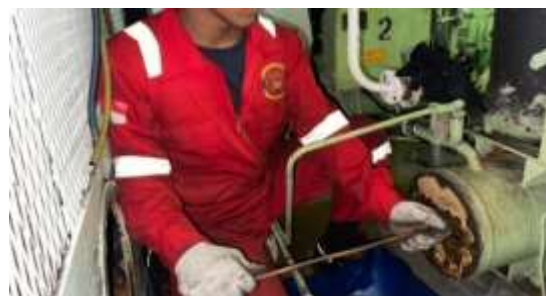
Figure 2. Condenser Cleaning Process

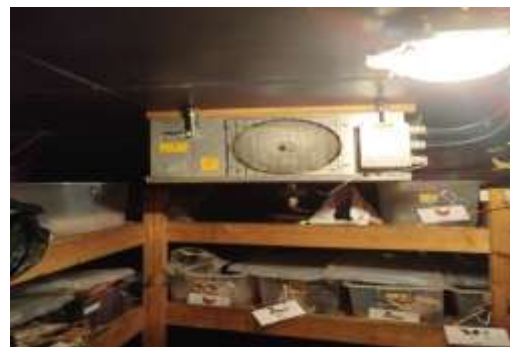
Figure 4. Condensor Fan
