## Journal of Engineering Science and Technology Management

### Analysis of the Decrease in Compressed Air Production of the Air Compressor onboard MT Seroja III

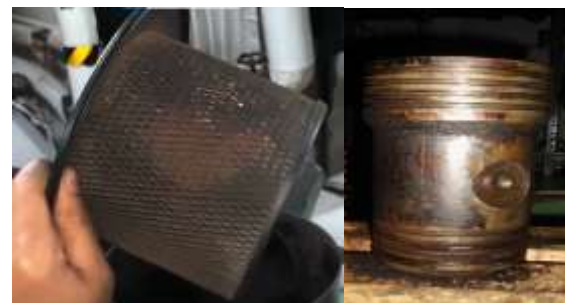
**Figure 1.** Maintenance

Physical teardown inspections of the unit revealed significant defects. The suction filter element was saturated with thick carbonaceous particulate matter and oily soot. Upon opening the cylinder head assembly, the first-stage suction and delivery valves exhibited severe carbon fouling, rough seating surfaces, and pitting wear. Inspection of the piston assembly showed that the piston ring gap had expanded to 1.85 mm, significantly exceeding the manufacturer's maximum wear tolerance of 0.60 mm, confirming blow-by symptoms

**Filtration Restoration:** The filter housing was dismantled, and the saturated element underwent reverse-flow pneumatic purging. The internal housing was chemically flushed with specialized solvent to eliminate oleaginous residues.

**Piston Ring Replacement:** The cylinder head was unbolted, and the piston assembly was extracted safely using a chain block to preserve cylinder liner integrity. After cleaning the carbonized ring grooves, new piston rings were installed with ring gaps carefully staggered at 120-degree intervals to eliminate blow-by pathways. Reassembly was tightened in a cross-torque pattern according to the manual instructions, followed by a controlled break-in running period.

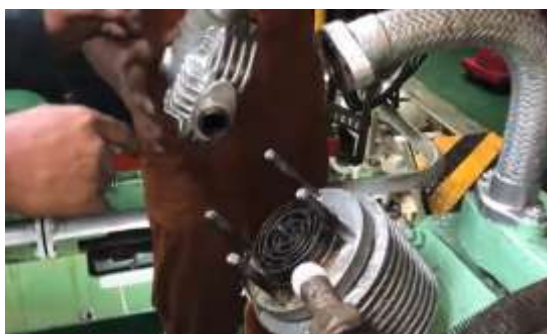
**Figure 2.** Suction and Delivery Valve

On June 6, 2024, Chief Engineer Sjahnur emphasized that the reduction in pressure is primarily attributable to the structural failure of the compression seal; specifically, the inability of the suction and discharge valves to seat correctly due to carbon deposits leads to significant back-flow leakage. He further highlighted that the gradual increase in the piston ring gap allows compressed air to escape during the compression stroke, a progressive failure mode that frequently goes undetected until system efficiency drops critically (Sjahnur, personal communication, 2024).

**Valve Overhaul:** The first-stage valve assemblies were completely disassembled. Carbon deposits and heavy sludge were chemically dissolved, followed by precision mechanical refacing and lapping to restore the

airtight sealing surfaces. Gaskets and valve plates were replaced with original manufacturer spares.
