## Journal of Engineering Science and Technology Management

### Proper Use of Mooring Lines on Ships to Ensure a Smooth Berthing Process on The MT. Giat Armada 04

The MT Giat Armada Bersama 04 is a tanker vessel (LOA: 90m, 3474 GT) utilizing a standard mooring configuration consisting of head, stern, and spring lines. The vessel is equipped with hydraulic mooring winches operating in tandem with 8-inch polypropylene mooring lines. The original specifications of these lines dictate a high initial Minimum Breaking Load (MBL) designed to safely secure the vessel's tonnage; however, the deck equipment configuration relies on cast-iron bitts and roller fairleads that require continuous anti-corrosion maintenance.

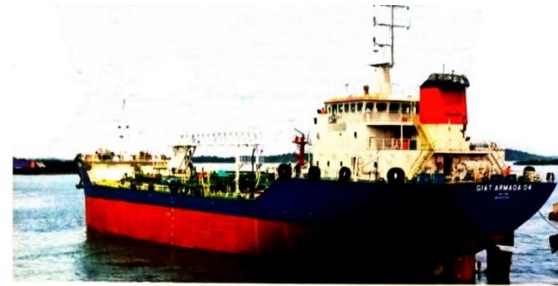
#### SPECIFICATIONS

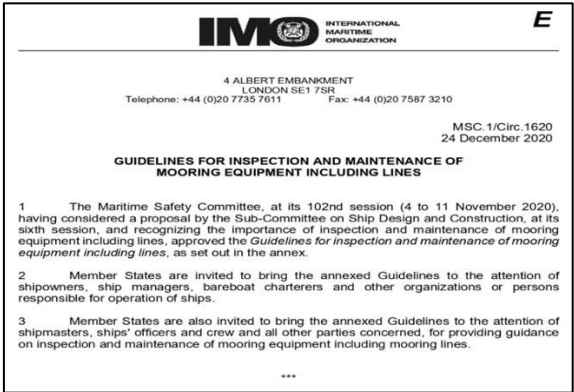
Fig 3. MSC.1/Circ.1619-1620

The physical deterioration of the spring lines has drastically reduced their residual strength. Because the ropes have exceeded the MEG4 retirement criteria (e.g., >10% broken strands and severe bird-caging), their actual breaking threshold is dangerously compromised, lowering the safety margin between the Working Load Limit (WLL) and catastrophic failure. Furthermore, the corroded state of the deck fittings prevents the smooth transmission of tension from the hydraulic winch. This excessive friction not only accelerates the localized thermal degradation of the synthetic fibers but also forces the deck crew to manually

intervene to clear jammed ropes, directly violating safe operational practices and resulting in consistent 10 to 15-minute berthing delays.

To resolve these operational bottlenecks, ship management must prioritize the immediate replacement of unseaworthy mooring lines and conduct rigorous routine inspections of all rope splices to ensure structural integrity. Furthermore, it is imperative to execute systematic cleaning and anti-corrosion maintenance on all supporting deck components, including bitts, chocks, and fairleads. Restoring these physical assets will minimize rope friction, prevent line tangling, and facilitate a smoother mechanical operation during the berthing sequence.

Operationally, the vessel must enforce a strict Line Management Plan (LMP) in alignment with OCIMF MEG4 and IMO safety standards to dictate clear retirement criteria for degrading ropes. This strategic management must be coupled with comprehensive pre-berthing equipment inspections and enhanced crew supervision, particularly during adverse
