Journal of Engineering Science and Technology Management

Optimization of Deck Crane Maintenance to Facilitate the Loading and Unloading Process on MV. Tanto Keluarga

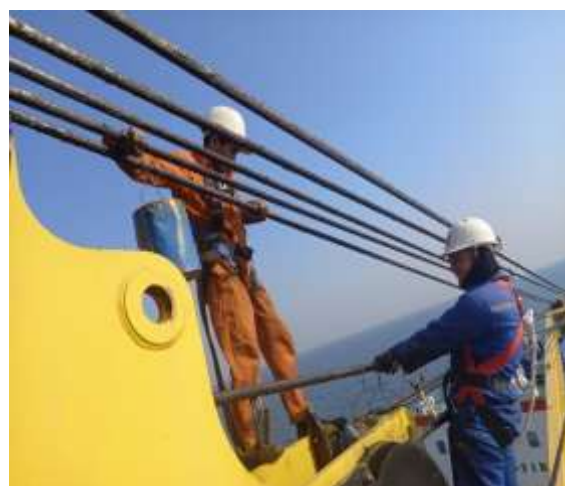
Figure 1. Re-greasing Wire rope Deck crane

Figure 1. Re-greasing the deck crane wire rope. This preventive maintenance activity restores necessary lubrication, mitigating frictional wear and preventing the severe downtime experienced in previous operations.

1. **Massive Re-Greasing:** The deck crew was assigned to immediately execute deep re-lubrication on the wire ropes and sheave blocks, and manually remove rust deposits from the slewing gear.
2. **Pre-Operational Layered Inspections:** The Chief Officer mandated a strict visual inspection checklist. The Able Seamen must verify sling cable integrity, hydraulic pump temperatures, and operator cabin cleanliness before the crane is energized.
3. **Schedule Harmonization:** Management submitted a formal request to the Marine Superintendent onshore to secure a "buffer time" in future port schedules, allowing dedicated operational breaks for PMS execution.
