# Journal of Engineering Science and Technology Management

## Analysis Of The Causes Of Suboptimal Steering Gear Performance Based On Maintenance Factors And The Quality Of Spare Parts On MV. Mulianim

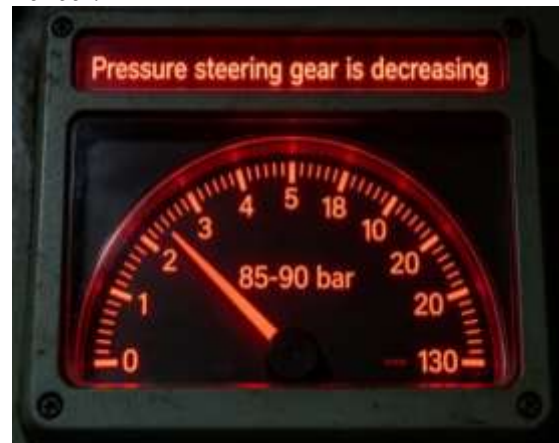
Figure 2. Steering Gear Hydraulic Pressure Condition

Field observations provided physical evidence supporting this maintenance deficit. Inspections of the steering gear room revealed micro-leaks (oil seepage) at several high-pressure hydraulic pipe joints. The hydraulic fluid extracted for visual inspection exhibited severe turbidity, indicating advanced contamination, though definitive claims regarding viscosity degradation cannot be established without diagnostic testing. Furthermore, during active maneuvering, the system's pressure gauge registered fluctuating pressures between 85 to 90 bar, failing to maintain the 100 bar operational baseline explicitly stated in the manufacturer's instruction manual.

| Machine (Condition) | Hydraulic pressure gauge registers drops to 85–90 bar against the 100 bar manual standard. | Associated with sluggish responses and delayed steering execution during critical maneuvering. |

| Problem Area | Interview Data | Observation Data | Documentation Audit | Synthesized Conclusion |
|---|---|---|---|---|
| Hydraulic Pressure Drop | Chief Engineer stated hydraulic pressure often drops during maneuvers. | Pressure gauge fluctuated between 85–90 bar (Manual baseline: 100 bar). | Engine Log Book recorded 6 occurrences of pressure drops during the period. | Converging evidence indicates a consistent decline in hydraulic system performance during operations. |

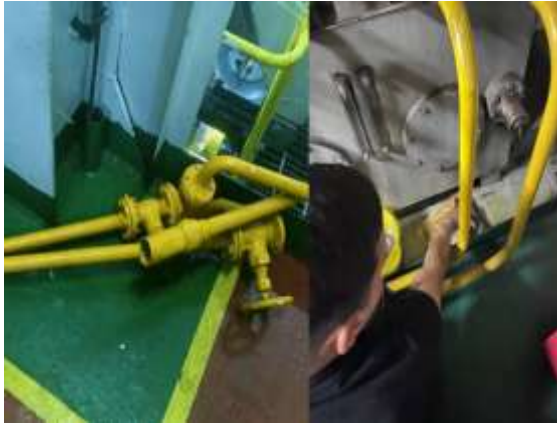
**Figure 3.** Hydraulic Steering Gear System Piping

The operational disruptions associated with delayed maintenance were severely exacerbated by a fragmented spare parts supply chain. The Spare Part Inventory List and Damage Reports indicated a chronic shortage of critical replacement components. Specifically, 2 out of 8 categorized critical spare parts for the steering gear (including specific hydraulic seals) were entirely depleted from the ship's inventory. The Oiler reported that due to procurement delays from the shipping company's shore management, essential replacements were stalled, forcing the continued use of wearing components.

| Problem Area | Interview Data | Observation Data | Documentation Audit | Synthesized Conclusion |
|---|---|---|---|---|
| Spare Parts Limitation | Chief Engineer stated hydraulic pressure often drops during maneuvers. | Oil seepage observed on pipe joints; extracted oil exhibited severe visual turbidity. | Damage Reports recorded oil leak disturbances. | Oil contamination and leakage are persistent, observable symptoms of system strain. |
