Journal of Engineering Science and Technology Management

Termites Attack on Residential Houses at Sialangmunggu, Tuah Madani, Pekanbaru

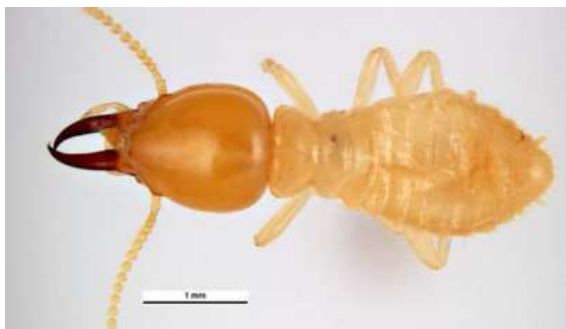
C. curvignathus belongs to the subfamily Coptotermitinae and the family Rhinotermitidae. It has a yellow head, with a body length of 3.17-4.91 mm, maximum head width of 0.72-1.01 mm, head length with mandibles of 1.29-1.97 mm, head length without mandibles 0.99-1.32 mm, and 15 antennae. The shape of the mandible is like a sickle and curved at the end. Figure 1 shows the soldier caste of *C. curvignathus* found at the study site. According to Harris (1971), there are 120 species of termites that attack buildings and 64 of them are very important names. *C. curvignathus* is the most ferocious termite species and is very common in Indonesia (Nandika *et al* 2003).

Fig 1. Soldier caste of *C. curvignathus* at 10 times magnification
